SERVICE BULLETIN 01/2010

Subject: Overheating of the instruments and plexiglass of the cockpit

Airplanes Affected (s.n.): Widebody cockpit airplanes: x xxx xxx M (year 2007), x xxx xxx N (year 2008), x xxx xxx O (year 2009), x xxx xxx P (year 2010).

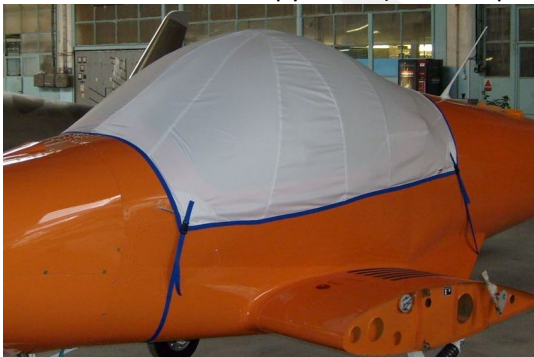
- Photo of the cloth canopy cover (ownership of JIHLAVAN airplanes, s. r. o.)

Action: Use a cloth canopy cover to protect the cockpit and the instruments from direct sunlight. Or provide good cockpit ventilation to prevent the cockpit and the instruments overheating.
