SERVICE BULLETIN 01/2014

Subject: GP One – never exceed speed limitation

Airplanes Affected (s.n.): GP One, all flying aircrafts

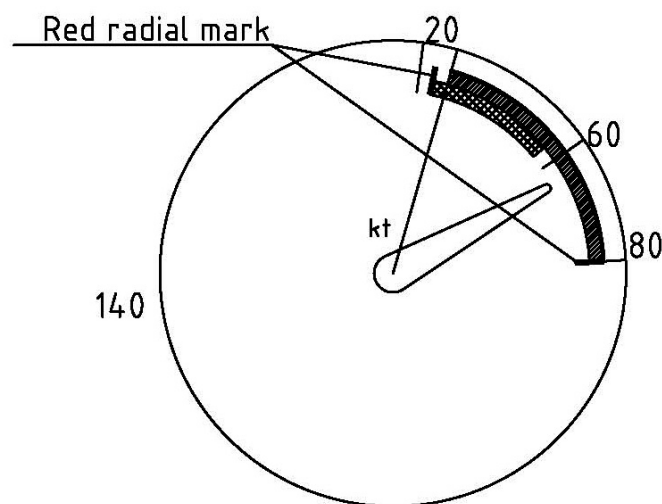
- Photo of the Airspeed indicator (ASI)

Reason: Flying at high airspeed can cause aircraft buffering and dangerous symptoms of flutter

Description: During flight test program it was established, that flying on top airspeed (approaching never exceed speed) can cause dangerous symptoms of flutter.

Action: Immediately perform an Airspeed indicator (ASI) re-marking to never exceed speed decrease to 80kt - via attached picture (in the bottom of letter).
