SERVICE BULLETIN 01/2016

Subject: Failure in wiring, possible battery discharge

GP One, KP-2U (Skyleader 200), KP-5 (Skyleader 500), JA-600 (Skyleader 600), JA-400 (Skyleader 400)

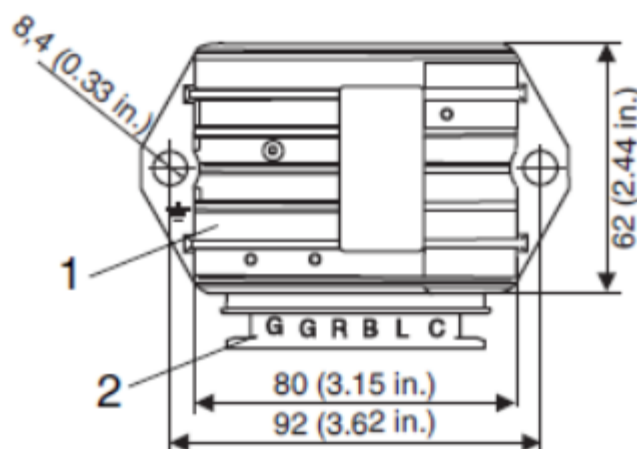
Pic 1: Rotax 912/914 regulator

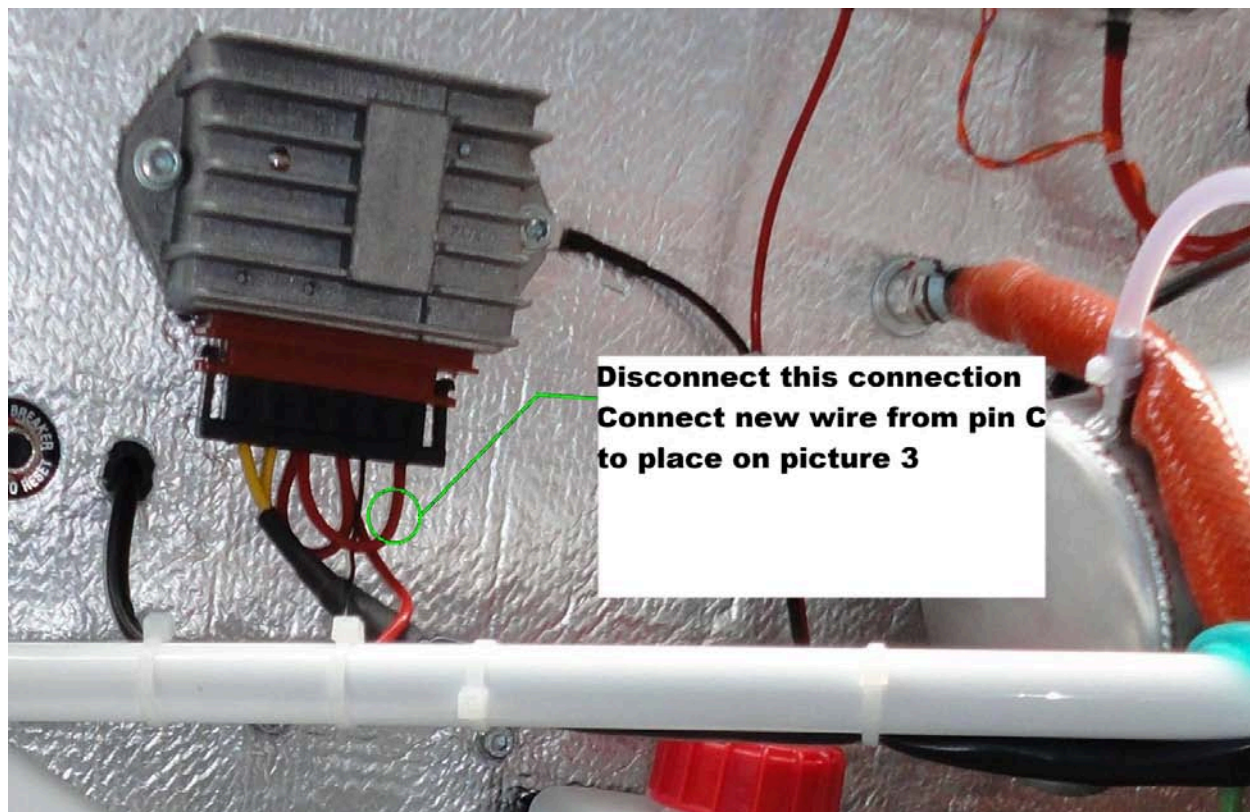
Description: During creating a diagram of the electrical installation error occurred and was connected permanent power supply +12V to pin C in connector (charging regulator). Correctly whether the power after the main switch is switched ON only.

Pic 2: Wrong connection between pins R and C

Action: Check if it is +12V on pin C during master switch is OFF (by voltmeter). If not, and appears after turning the switch ON, so the airplane is correct and does not need any actions. If yes: reconnect power supply of pin C in connector from permanent power supply +12V to switching power supply.

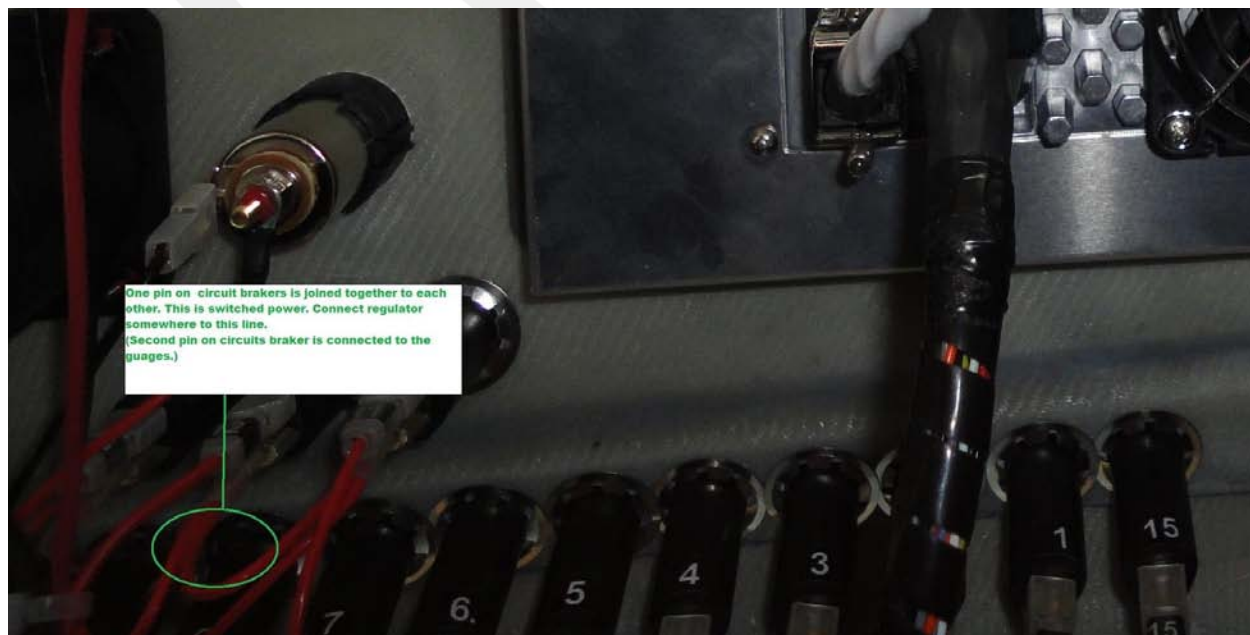
Pic 3: Place for new connection with pin C
