## SERVICE BULLETIN 01/2017

**Subject:** Increase security of ballistic rescue system

**Airplanes Affected (s/n):** JA-400:

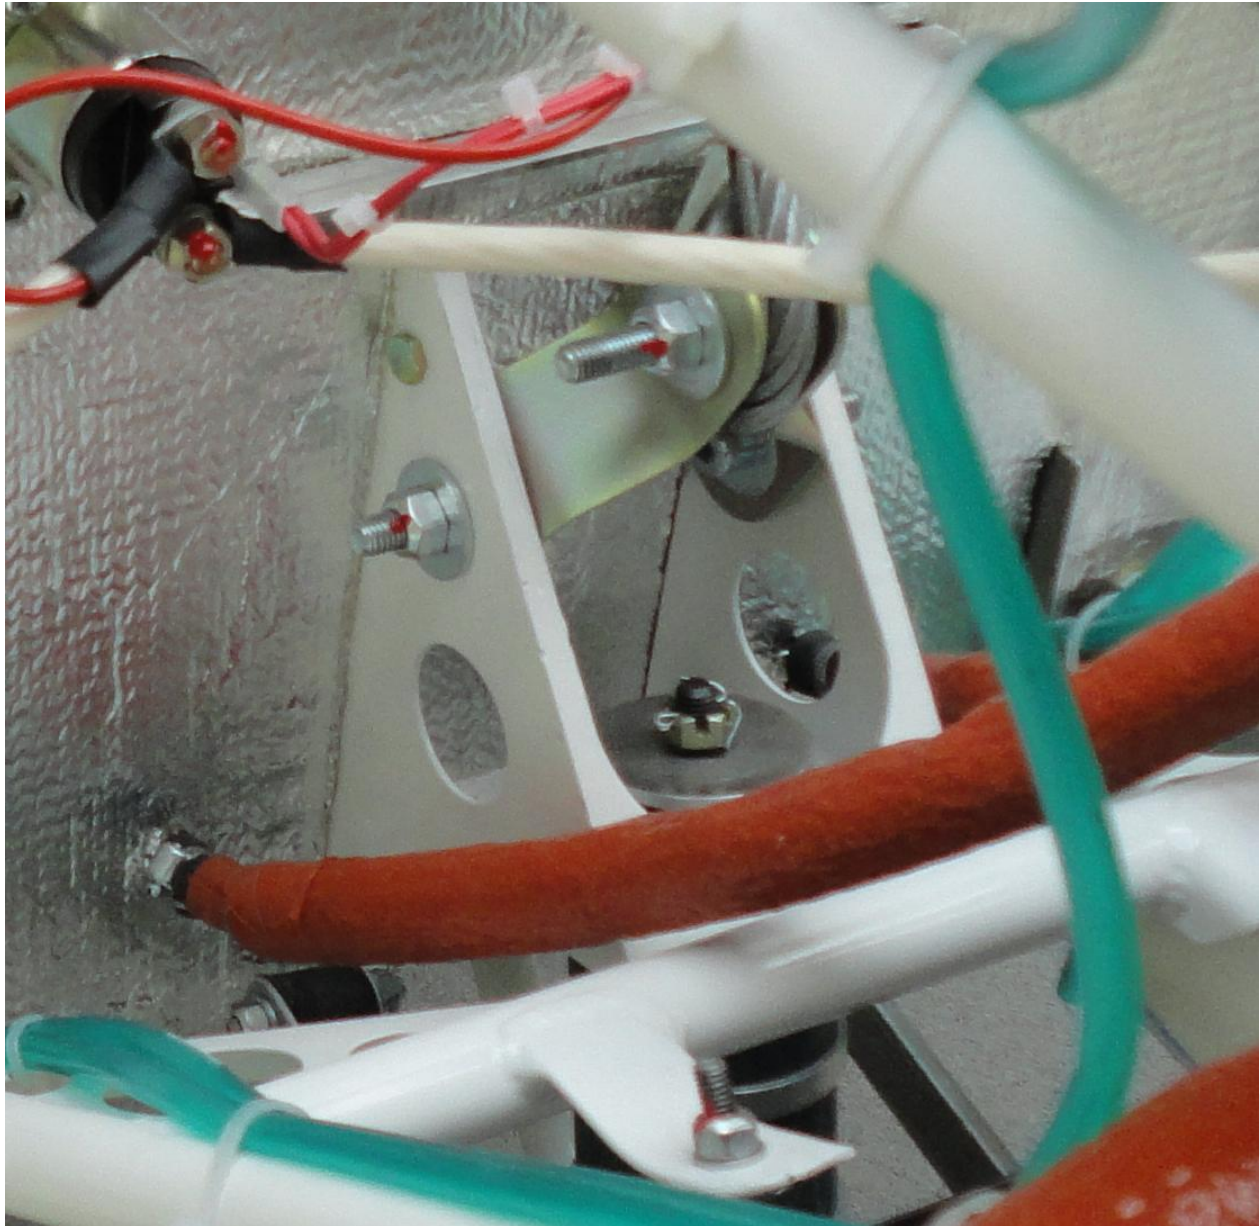
Old solution:

**Reason:** Improving safety hinge rescue system

**Description:** Exchange parts in hinge rescue system.

**Action:** Please, you must to change parts in hinge rescue system. Please refer to the enclosed drawing documentation. Tightening torque is 25 Nm for nuts. It is necessary to insure nuts by Loctite Threadlocker Blue 242 or similar.
