## SAFETY INFORMATION BULLETIN 09/2022

**Bulletin number:** 09/2022

**Subject:** Tightening the bolts from the engine bed to the engine block

**Airplanes affected (s/n):** All types without engine bed ROTAX (Aircrafts with a only engine bed): JA-200 (Skyleader 200), JA-400 (Skyleader 400), JA-500 (Skyleader 500), JA-600 (Skyleader 600), GP One

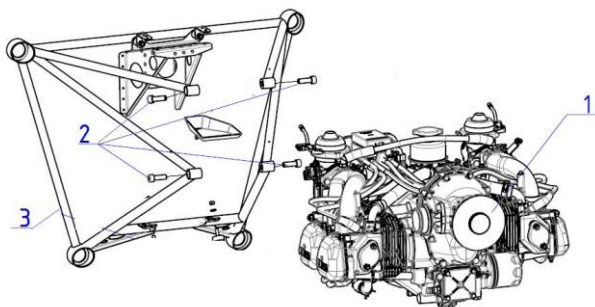
**Reason:** Preventing the possibility of in-flight release, as a result of vibrations and thermal shocks of the engine, the powder coating on the contact surfaces of the engine bed can be extorted. Despite the fact that the screw is sealed with thread glue, a small play may appear on the contact surface, which is undesirable.

1 - Engine 2 - 4pcs of Bolts 3 - Engine Bed

**Action:** After the first 50 engine hours, it is necessary to check the tightening of the screws from the engine bed to the engine, tightening torque 50 Nm. Carry out other screw tightening checks at regular service intervals. If it happens that the screw is not tightened to the required torque, it is necessary to turn it, apply a new layer of thread adhesive Loctite 243 or equivalent and tighten with a torque of 50 Nm. During assembly, do not forget to return the Z-type disc spring under the screw head, if it is not damaged, in case it is necessary to replace it.
